REMARKS CONCERNING UNDERMINED TRANSVERSE HYDROTECHNICAL STRUCTURES USED FOR TORRENTIAL WATERSHED MANAGEMENT IN CRIS RIVER CATCHMENT

Abstract

The paper presents some research results regarding one of the most important damage that occur during torrent control hydrotechnical structure service. First, it refers to the occurrence frequency of undermining in the environmental conditions of Cris catchment area. In 10 torrential watersheds and improvement perimeters 315 transverse hydrotechnical works were studied. The paper analyzes the influence of structure elevation height and the influence of structure's downstream sustainability by another hydrotechnical work; over the frequency rates of the event, trying to establish what kind of structures are more vulnerable to be undermined. After a short presentation of the undermining characteristics, it is presented how this behavioural event influence the general condition of the structure through its impact over the ruptures that occurred and over structures condition rate. Finally the role of the riverbed lithological structure, the sediment size grading and the sustainability of the structure over the intensity of undermining were studi

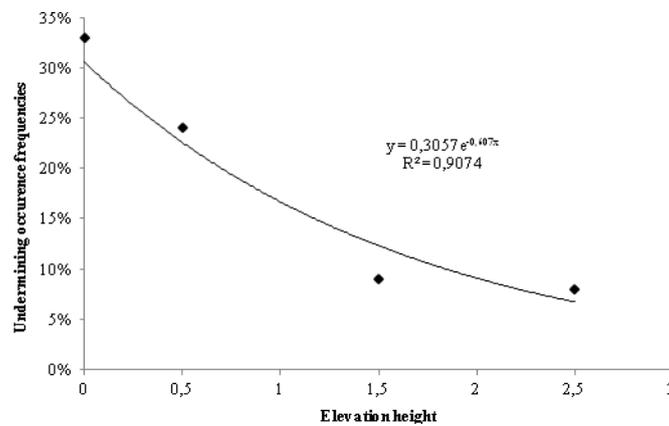
Undermining was mentioned at 24 transverses (representing 33% from the total amount of them), 25 sills smaller than 1 m height (24%), 6 sills having a height between 1 and 2 m (9%) and 3 dams with a height between 2 and 3 m (8%), in this last category being included both structures with an apron, mentioned above. Excluding from the analysis those hydrotechnical works having an apron, the proportion of undermined transverses is 38%, of 1-2 m sills is 37%, of 1-2 m sills is 20% and of 2-3 m dams is 4%; resulting a significant reverse correlation between the occurrence frequencies of undermining and the structure height (fig. 1), the regression indicating a lower risk of undermining as structure height increases.

Fig.1 The occurrence frequencies of body undermining depending on elevation height

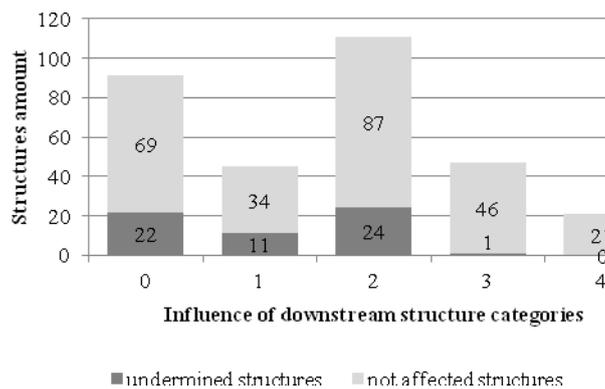
Referring to the influence of downstream structures over the occurrence frequencies of this behavioural event, a larger proportion of structures without support or with a small support from downstream (categories of downstream structure influence 0 and 1) are affected comparing to the others categories. As illustrated in figure 2, 24% from structures not benefiting from downstream support are undermined, the same percentage of affected structures being in category 1 of influence from the downstream structure; while the structures included in category 2 of downstream support being affected in 22% of cases and the fully supported hydrotechnical works (category 3) being undermined only in 2% of cases. The structures that capture water for a drain channel are not affected by undermining.

Fig.2 Transverse works with undermined body related to downstream sustainability

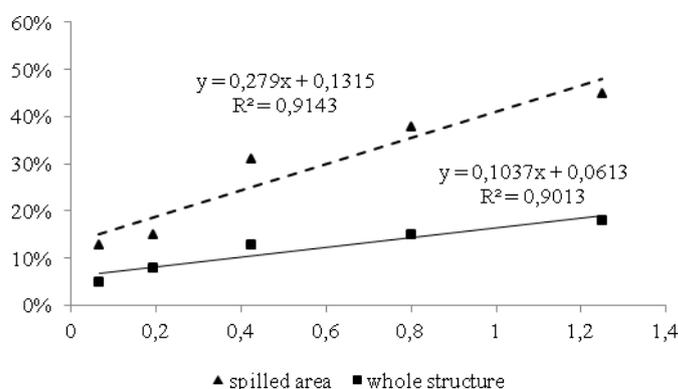
Mentioning that 22% of undermined structures are not affected by other damages, we have noticed that undermining is linked especially with ruptures, 48% from these structures having fragments of their body detached. The close connection between those two behavioural events is also highlighted by the significant correlation between the undermining intensity (expressed by the product between undermining depth and the proportion affected) and the percentage of the detached fragments from the spilled area, respectively from the whole structure body (spilled area and body wings), as shown in figure 3.

Fig. 3 Correlation between body undermining intensity and the proportion of body structure broken, in case of transverse works affected by both damages

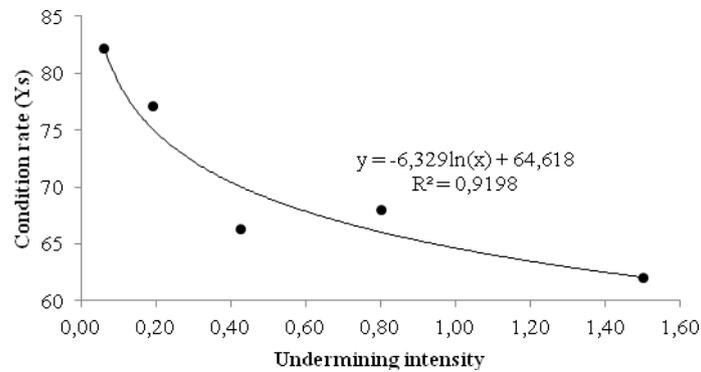
The average condition rate for undermined structures is 70.2, being with 18% lower than the condition rate of not undermined structures (86.0) and 15% lower than the average condition rate of structures within Cris catchment (83.1). This indicator varies significantly according to the this particular damage intensity (fig. 4)

Fig. 4 Structures condition rate (Y_s) depending on body undermining intensity

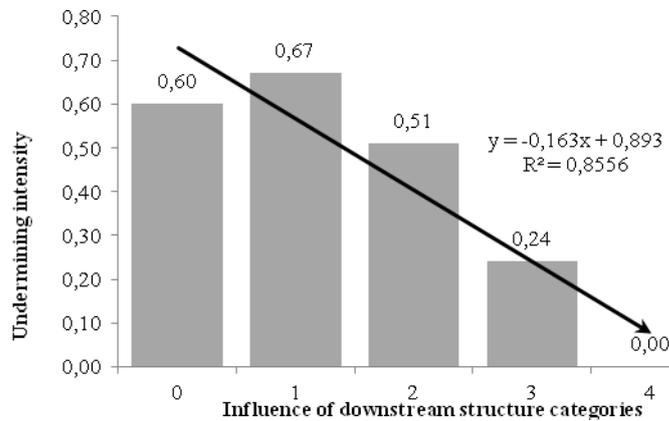
The support of a downstream structure is important not only in terms of the risk of developing the damage but also in terms of its intensity. Thus the event intensity is much lower when undermined structures are fully supported by downstream structure (0.24) comparing to the rest of undermined structures for which the average intensity is 0.57 (fig.5).

Fig.5 Body undermining intensity depending on downstream sustainability
