ASPECTS CONCERNING THE PRESENCE AND THE GRAVITY OF THE FOREST-CRACK ON *QUERCUS CERRIS* (THE TURKEY OAK) SPECIES IN THE FOREST STANDS AS PART OF TINCA FORESTRY DISTRICT

Bartha Szilard*, Dorog Lucian Sorin, Cărădan Adina Mioara

*University of Oradea, Faculty for environmental Protection, 26 General Magheru Street, 4100848, Oradea, Romania; szilardbartha@yahoo.com

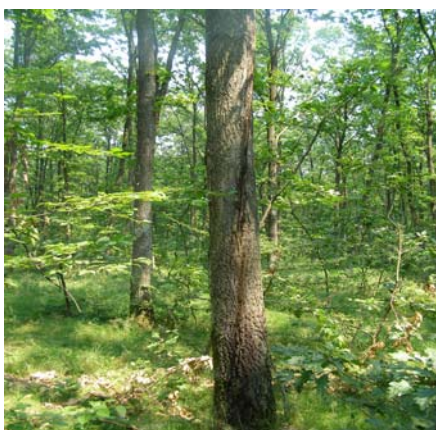
The frost-crack is a wood structure defect, a longitudinal and elicoidal crack, which occur on trees during winter due to the frost (the water inside the wood freezes, increases its volume and the wood cracks).

Fig. 1 The aspect of a frost-crack on a standing tree

The frost-crack can either be closed (the crack doesn't reach the edge of the trunk transversal section) or opened (visible at the exterior side) and generally presents crest-shaped swellings on the exterior sides.

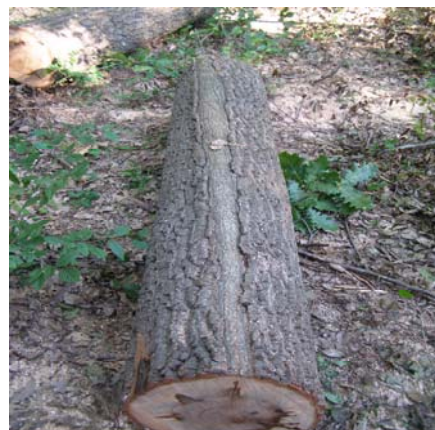
Fig. 2 The aspect of a frost-crack on a Turkey oak timber

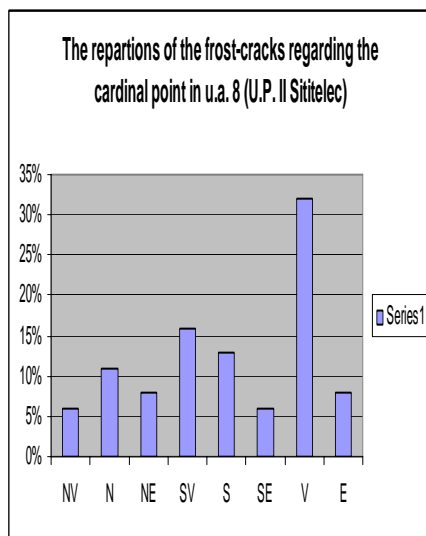
Fig. 3 The repartions of the frost-crack's regarding the cardinal points in u.a. 8

Analising the charts above it comes out that the frost-crack's exposition concerning the main cardinal points, the western (32% and 26%) and south-western (16% and 22%) on both sample plots are the most frequent.

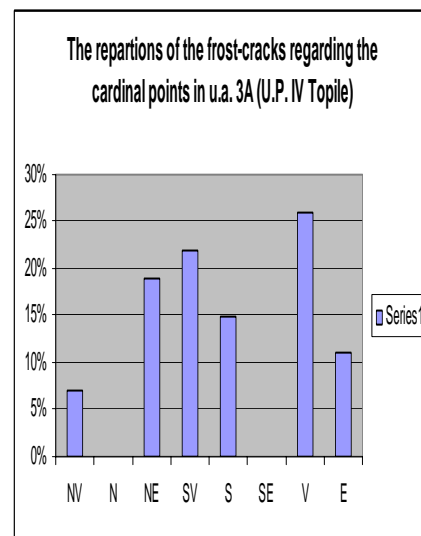
Fig. 4 The repartions of the frost-crack's regarding the cardinal points in u.a. 3A
