**MODELS OF EVOLUTION OF ARTIFICIAL AGRICULTURAL TERRACES ON  
THE RIGHT SIDE OF CRISUL REPEDE RIVER  
(ORADEA-ALESD AREA, BIHOR COUNTY)**

**Nistor Stelian\***

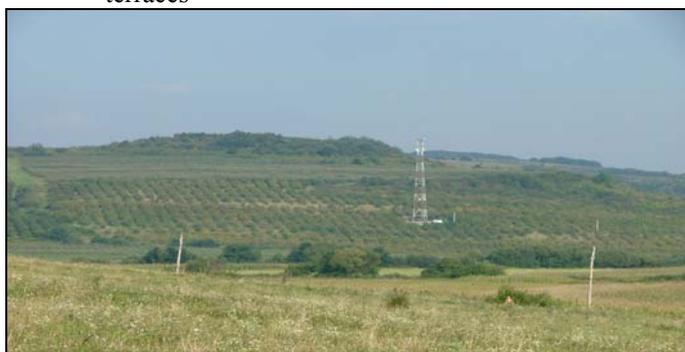
Fig. 1 Terraced slope with active agricultural use in Alesd area (source, Nistor S.)

In the case of this type of slope one could observe two situations: agricultural terraces with a present agricultural use, these terrace systems being preserved and thus offers an efficient anti-erosional protection and a low dynamic evolution (see fig. 1). The most characteristic area in which agricultural terraces are still present is around Alesd and Lugasul de Jos localities.

The evolution is performed on different sectors, the agricultural terraces being geomorphological thresholds conditioning the evolution of the slopes. The use of the terraced slopes was mainly orchards or vineyards. Within a slope one could distinguish two elements:

- a horizontal surface, in length of about 5 m, analogous to treads of fluvial terraces
- the batter, in length of about 2 m, analogous to risers of the fluvial terraces

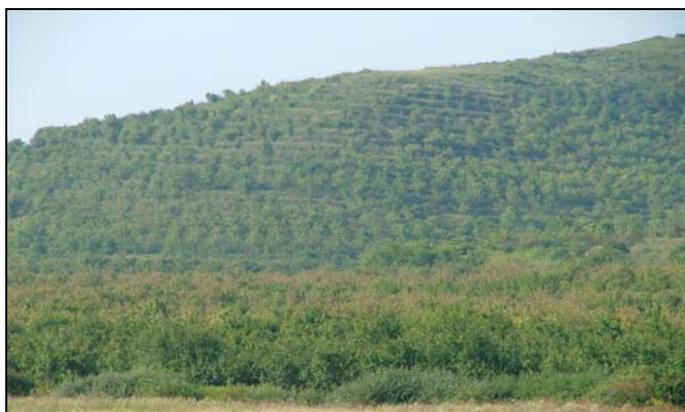
A particular way of appearance of these agricultural terraces is around Oradea, on the right side of Crisul repede river. In this area the system of terraces were abandoned, there is no longer an agricultural use of the slope, but the existence of the former orchards, now abandoned, still give a relatively high protection of the slope in terms of low morphodynamic.

Fig. 2 Terraced slope with abandoned orchard next to Oradea (source, Nistor S.)

This stability of the slope is a relative one, the slope being in an intermediate evolution state, between an human-controlled evolution and a natural one of the terraced slope.

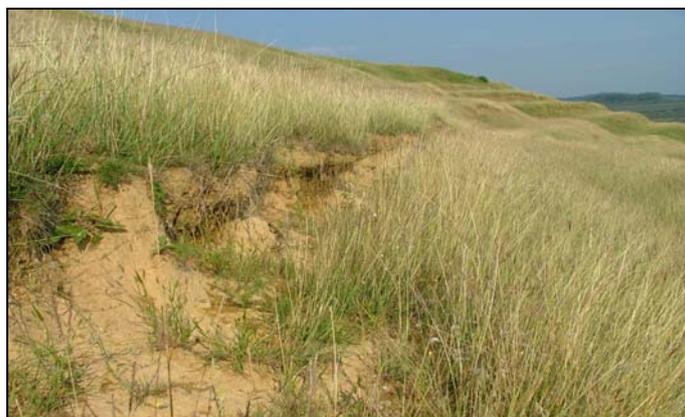
Fig. 3 The riser and tread subsystems of an agricultural terrace next to Uileac village (source, Nistor S.)

*The riser of the terrace* evolves under the impact of geomorphological processes such as small dimension landslides. The dimension of the scarp is 0.30-0.50 m and the mean volume of slided mass is  $0.75 - 1.25 \text{ m}^3$  (Nistor S, 2006). From the moment of disappearance of the uniformity of the tread, under the conditions of implicit destruction of vegetation cover, the water-controlled processes play an important role, under favorable geological conditions (sandy clays, sands, slightly consolidated marls).

*The tread of the terrace* is characterized by a relative stability, its evolution being defined mostly by accumulation processes of the materials from the riser of the upper terrace. The dynamic of these subsystems is directly dependent on the evolution of the upper subsystems, the disequilibrium which appears here directly conditioning the evolution of these subsystems.

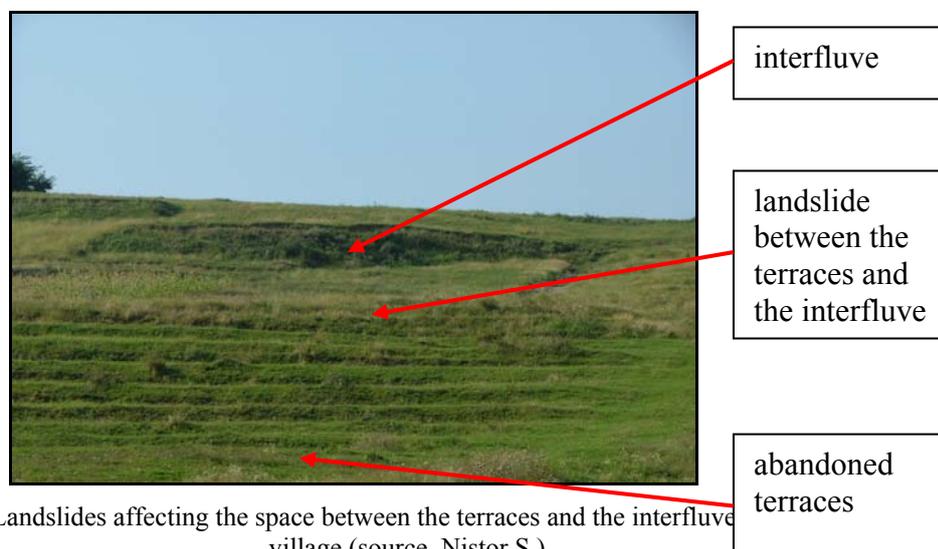
dimensions and dynamic, in this case the processes are big in dimension and are very active (see fig. 4).

Fig. 4 Landslides affecting the space between the terraces and the interfluve village (source, Nistor S.)

The land slides are the main processes which condition the evolution and the dynamic of these subsystems. From dimensional point of view the scarp of these landslides are relatively small (2.5-4 m) but very dynamic. The speed of evolution is directly linked by the value, character and the seasonal repartition of the rainfalls

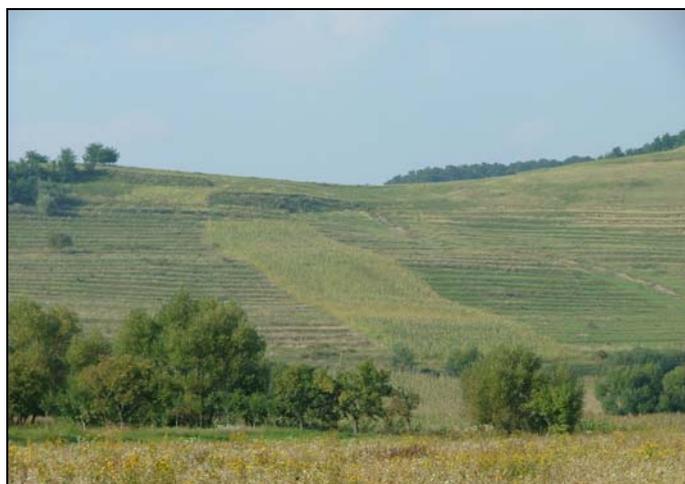
- the destruction of the agricultural terrace through plowing. In this case the slope has an relatively degree of protection (see fig. 5)
- the appearance of vertical erosion with an irreversible direction of evolution (see fig. 6)

Fig. 5 Destroyed agricultural terraces next to Uileac village (source, Nistor S)

The structural and geological conditions very soon lead the slope to a very rapid turn in terms of specific geomorphological processes: if in case of stage one the dominant geomorphologic process is given by sheet erosion, in the second stage of evolution the dominant processes are the vertical erosional processes - rill, gully erosion (see fig 6.). In this case the geomorphological processes are irreversible and the most important consequence of the change of the dominant process is the impossibility of any agricultural use. In terms of slope evolution this stage means the change of conditional factor, from a factor controlled by the presence of the agricultural terrace, to a factor controlled by the base level of the slope.

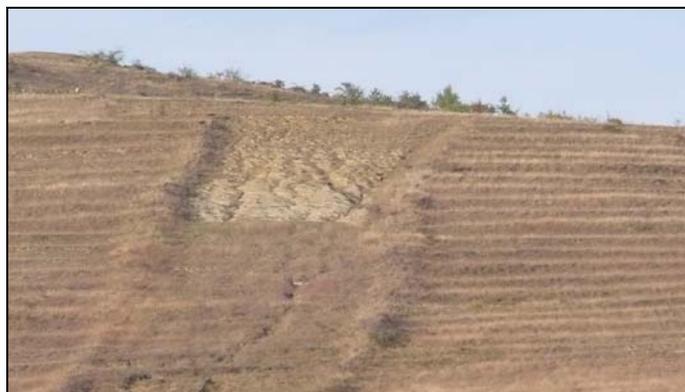
Fig. 6 Slope affected by gully rill and gully erosion next to Alesd (source, Nistor S.)
