STUDIES ON IDENTIFYING THE TYPE AND RATE OF CORROSION OF METALLIC MATERIALS IN GEOTHERMAL PLANTS. CASE STUDY

Abstract

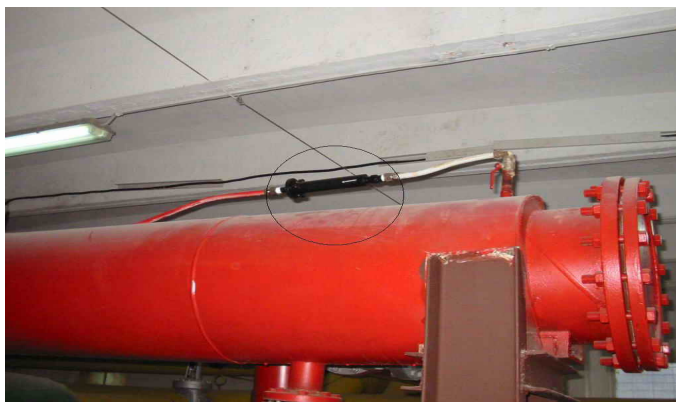
Fig. 2. Positioning of the experimental device in the installation

To study the phenomena that take place in the transport system of the thermal water, we interposed the experimental device on a by-pass of the pipe that leads the thermal water from the degasers, through pumping, to the entrance in the heat exchangers, as it can be seen in *figure 2*.

During the experiment, the device was full of water in circulation.

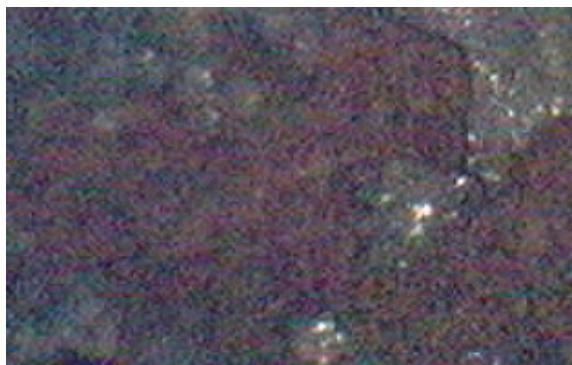
Fig. 3. Aspect of the surface covered with corrosion products

The corrosion products were observed with a surface metallographic microscope CITIVAL, for macrosections. The achieved image is presented in *figure 3*.

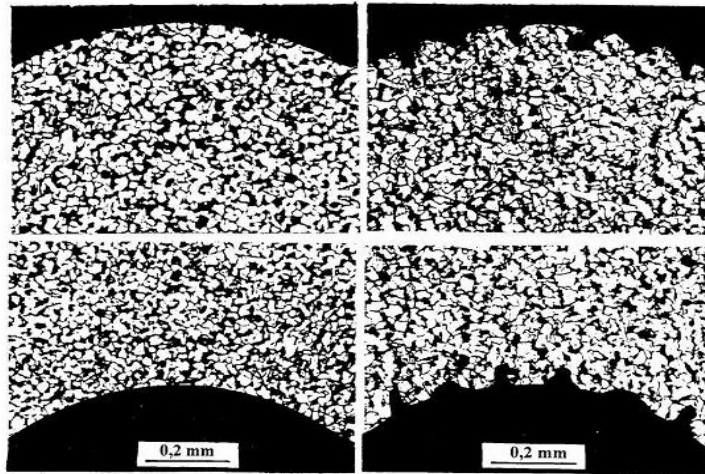
Fig. 4. Image of pointed corrosion

The microstructure of the marginal areas was highlighted by attacking the sample with a solution of 1% Nital (Cook R.,1998). The metallographic structures are ferrito-perlitic, mostly ferrite. The steel granulation is of 0.02 mm. After the metallographic analysis, a corrosion process through pits have started, on a depth up to 0.1 mm, in the marginal area. (figure 4)

The metallic material that reached the highest corroding rate is OLT 45 R in the water of the well 4797. The sample from by-pass III, made up of this material, was observed with the help of the metallographic microscope. No geometrical changes of the sample during the experiments have been recorded. After the metallographic analysis, a corrosion process through pits have started, on a depth up to 0.1 mm, in the marginal area.
